**REPORT NUMBER: SPNCAP-CAL-16-004**

**NEW CAR ASSESSMENT PROGRAM (NCAP)  
SIDE IMPACT POLE TEST**

**Honda MFG of Indiana, LLC  
2016 Honda Civic  
Four Door Sedan**

**FINAL REPORT**

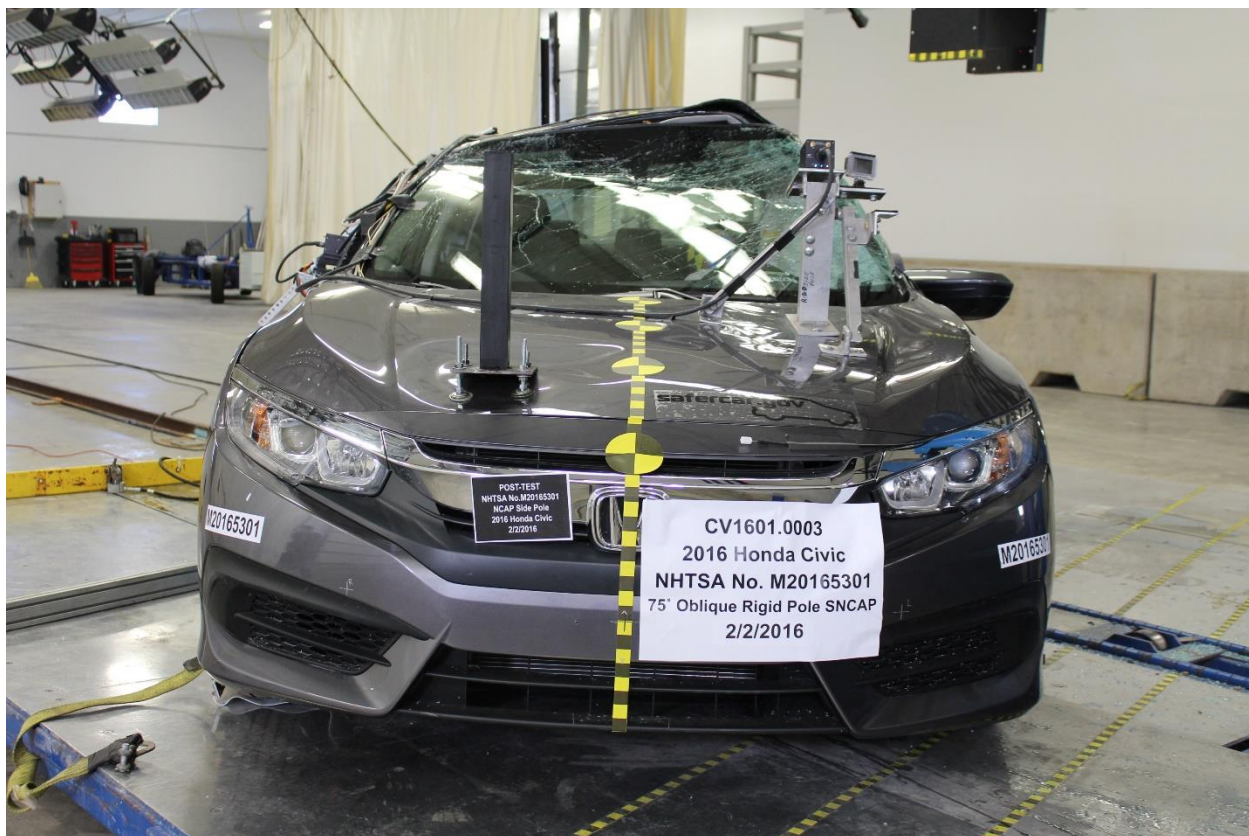
**Figure A-4: Post-Test Frontal View of Test Vehicle**

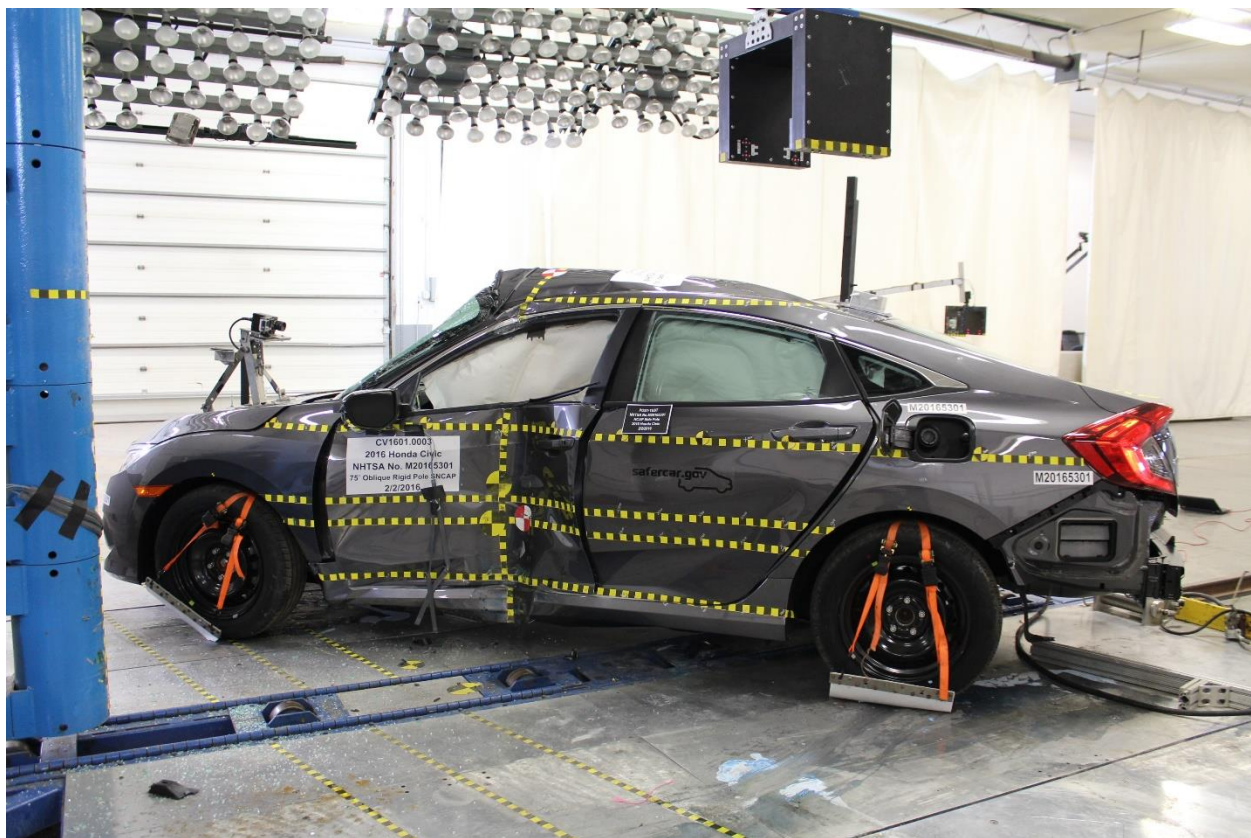
**Figure A-8: Post-Test Left Side View of Test Vehicle**

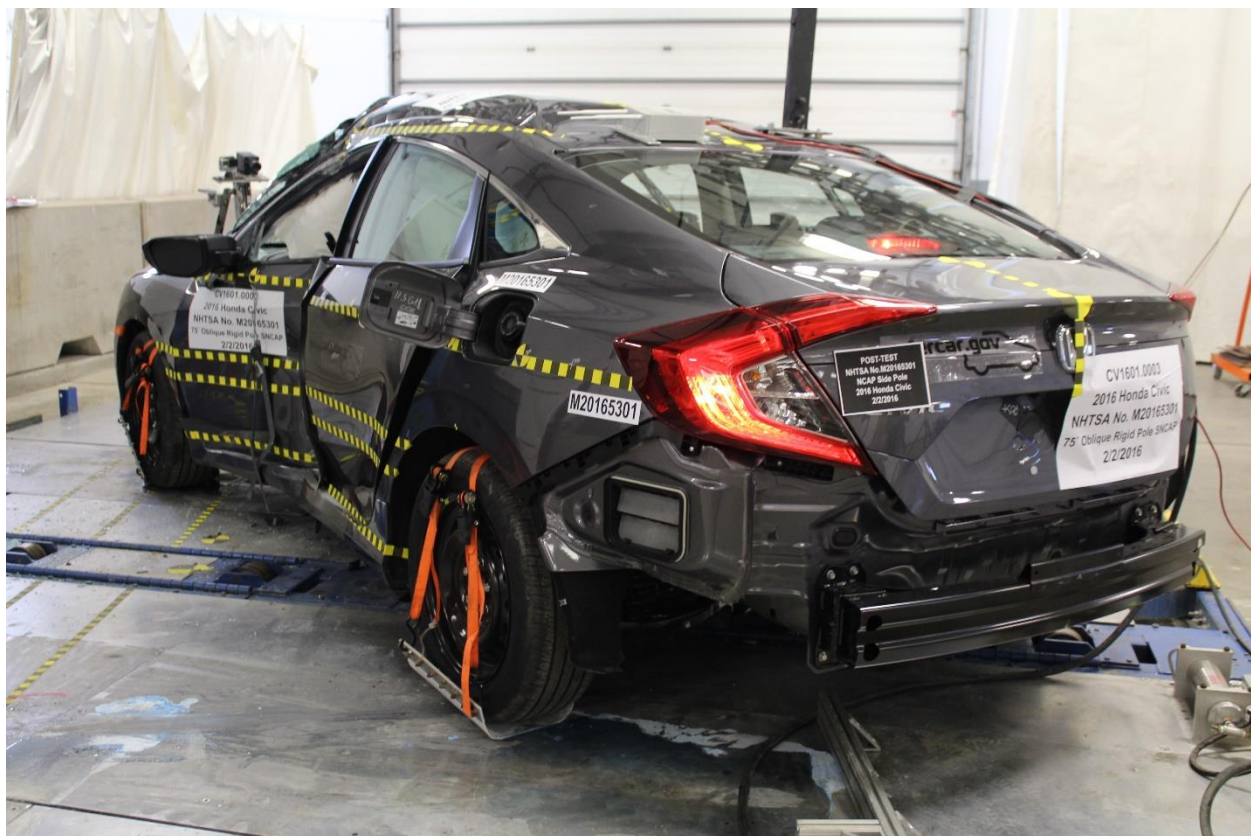
**Figure A-10: Post-Test Left Rear  $\frac{3}{4}$  View of Test Vehicle**

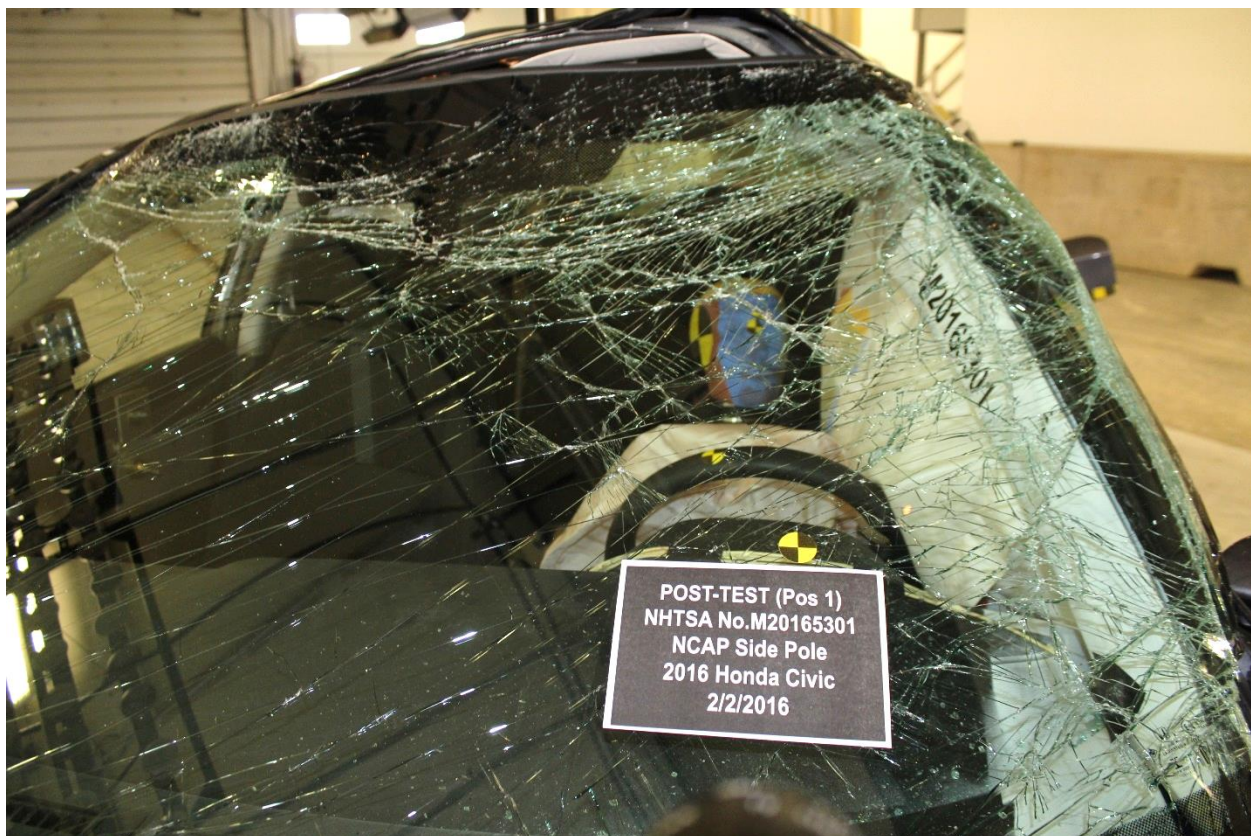
**Figure A-22: Post-Test Front Close-Up View of Dummy**

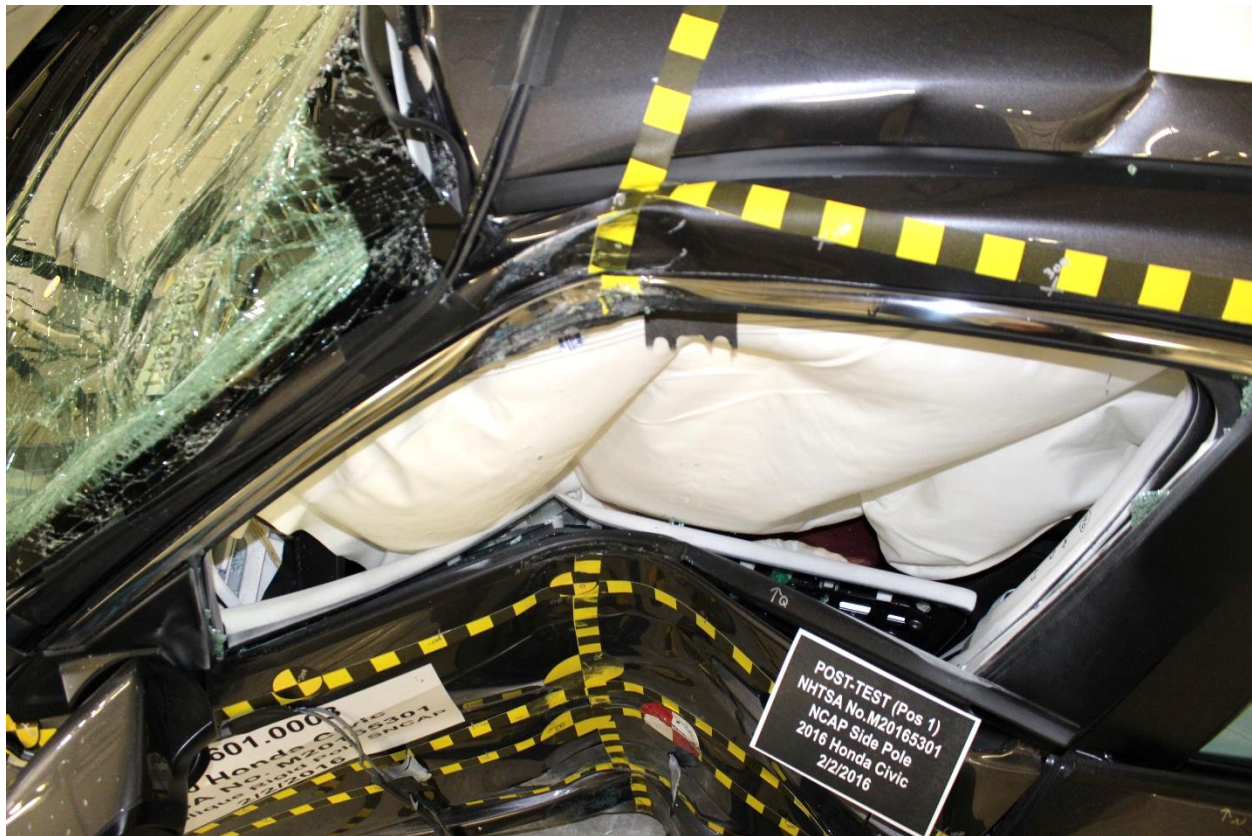
**Figure A-41: Post-Test Dummy and Door Clearance View**

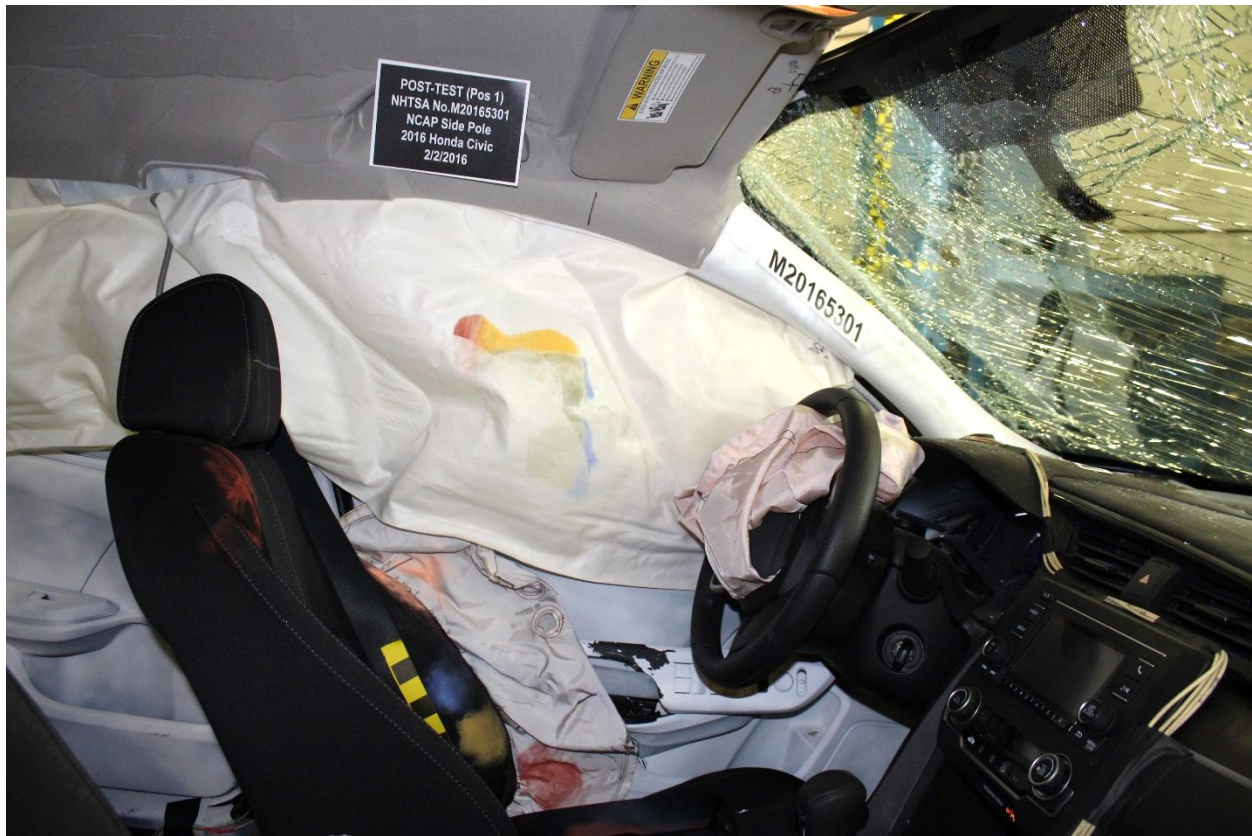
**Figure A-45: Post-Test Inner Door Panel View Showing Dummy Contact Location**

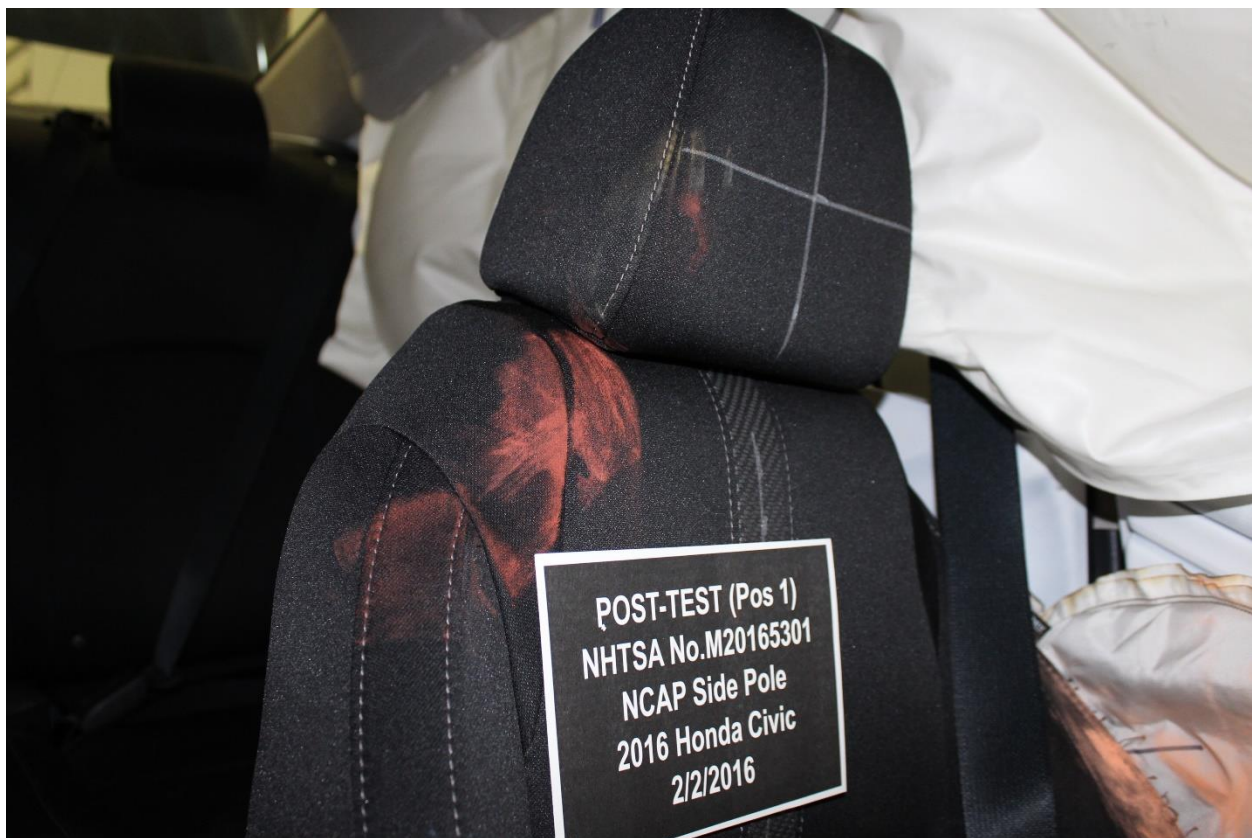
**Figure A-46: Post-Test Dummy Close-Up Head Contact with Vehicle Interior View**

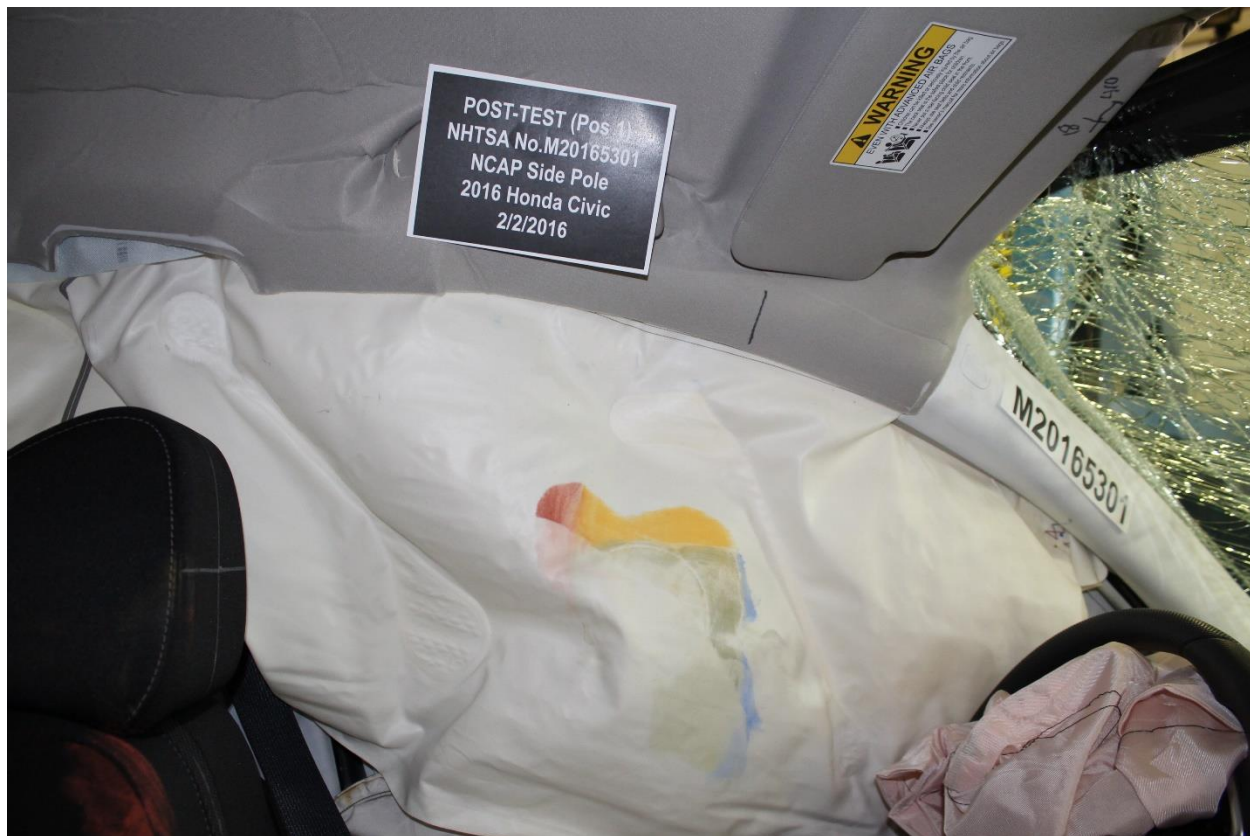
**Figure A-47: Post-Test Dummy Close-Up Head Contact with Side Airbag View**

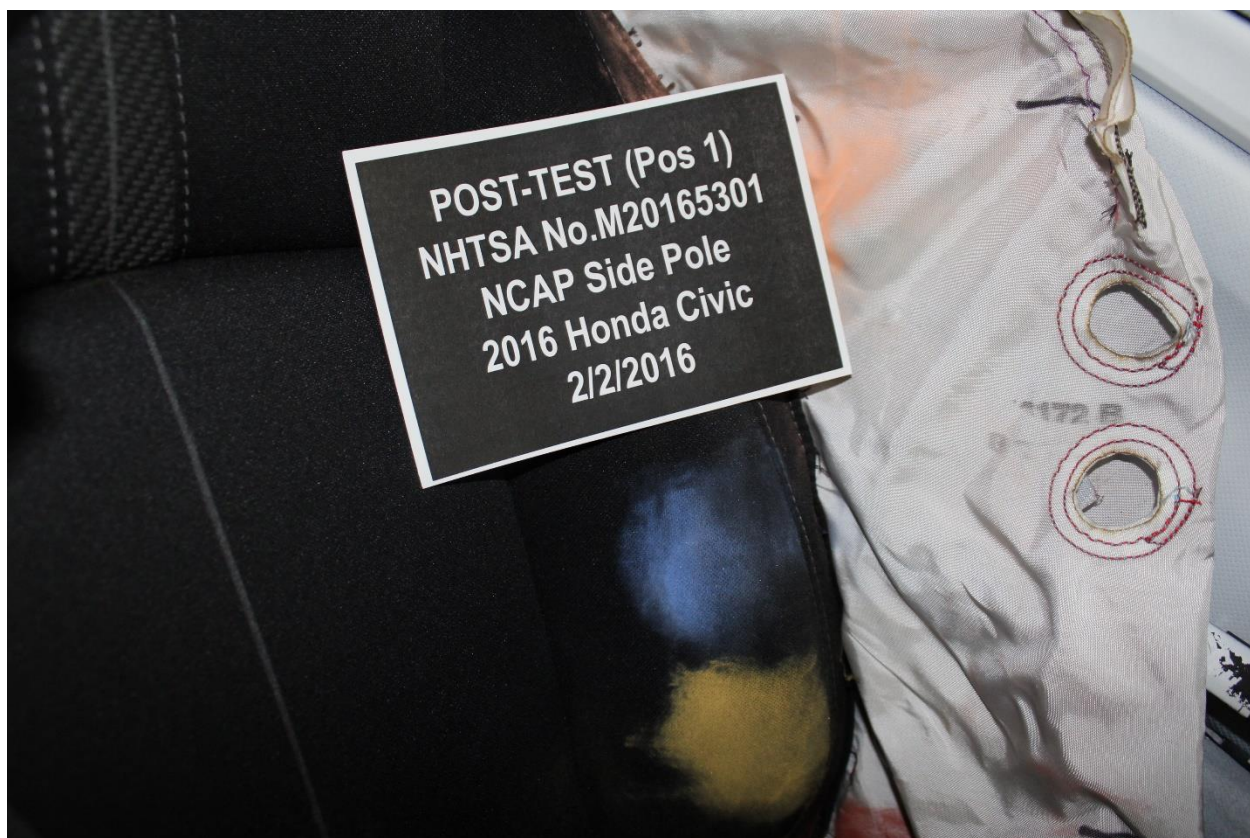
**Figure A-48: Post-Test Dummy Close-Up Torso Contact with Vehicle Interior View**

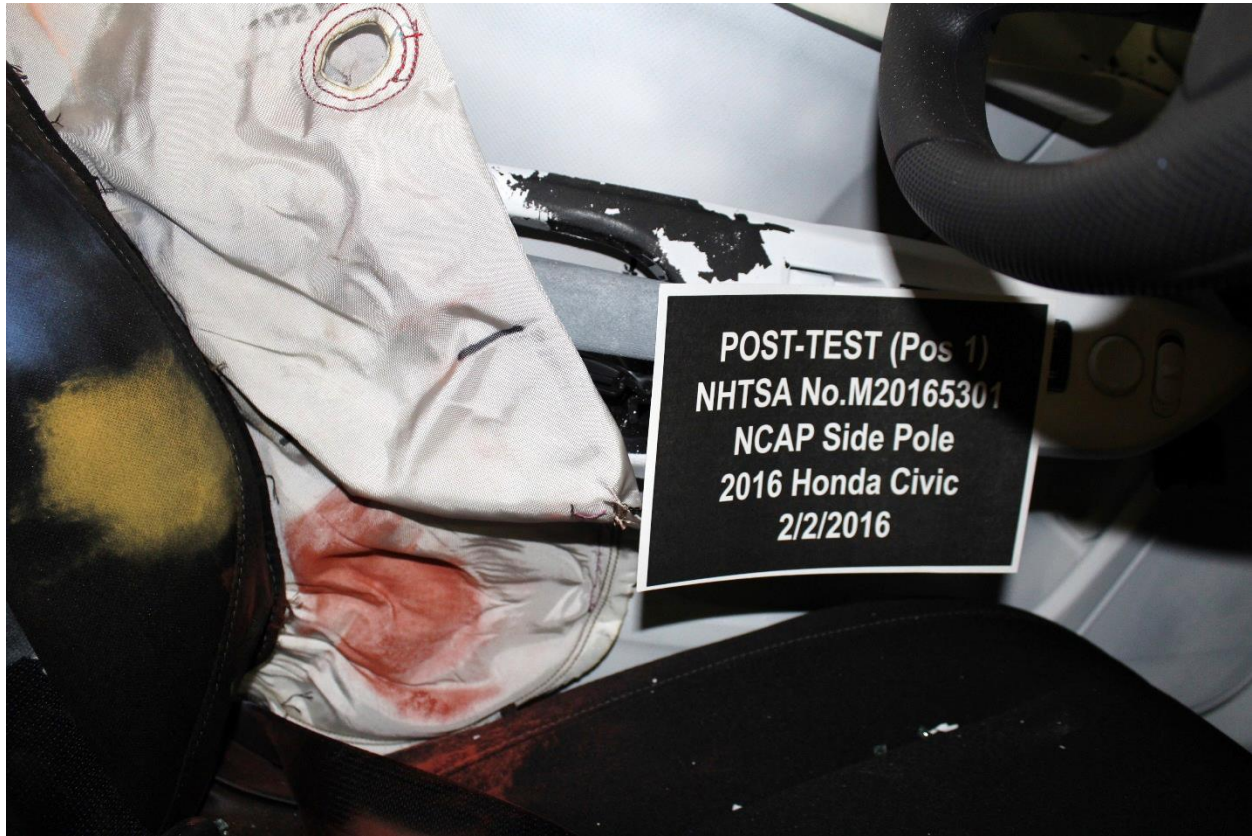
**Figure A-51: Post-Test Dummy Close-Up Pelvis Contact with Side Airbag View**

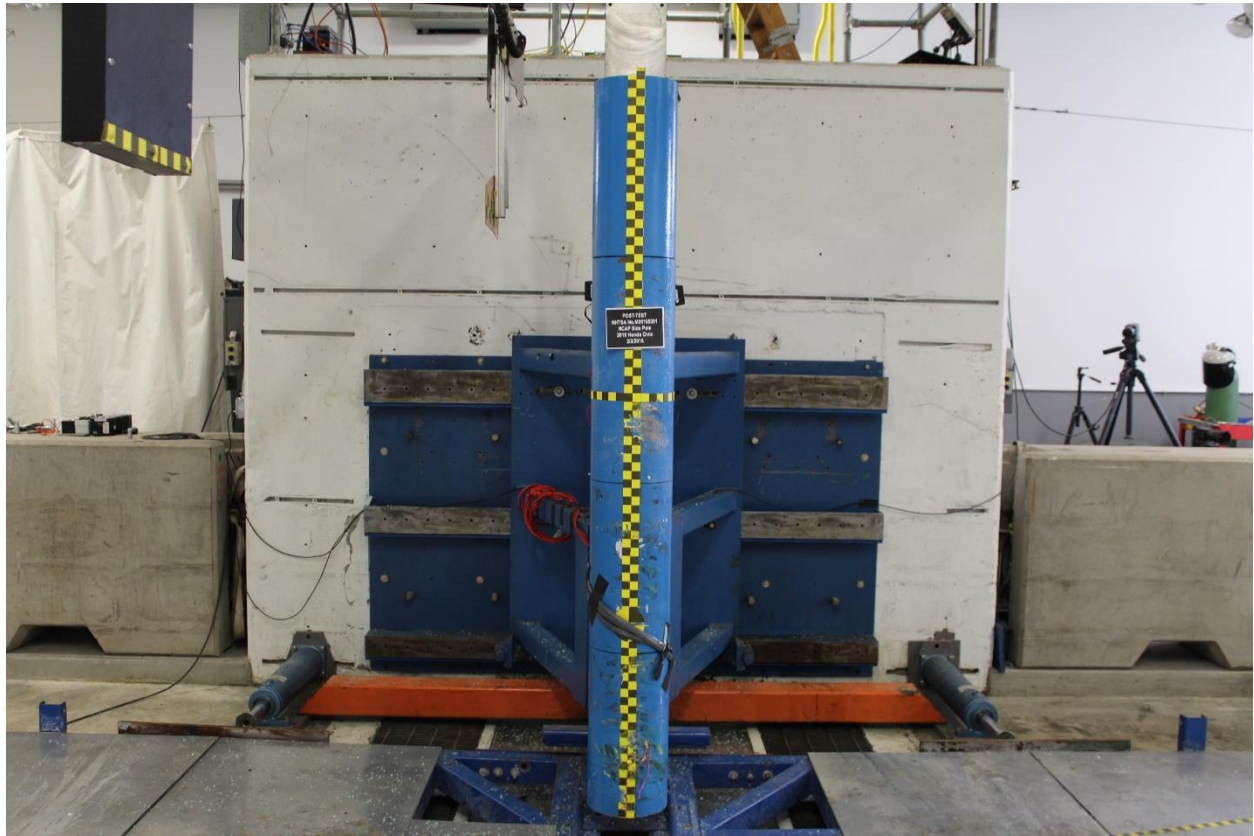
**Figure A-58: Post-Test Pole Barrier Front View**

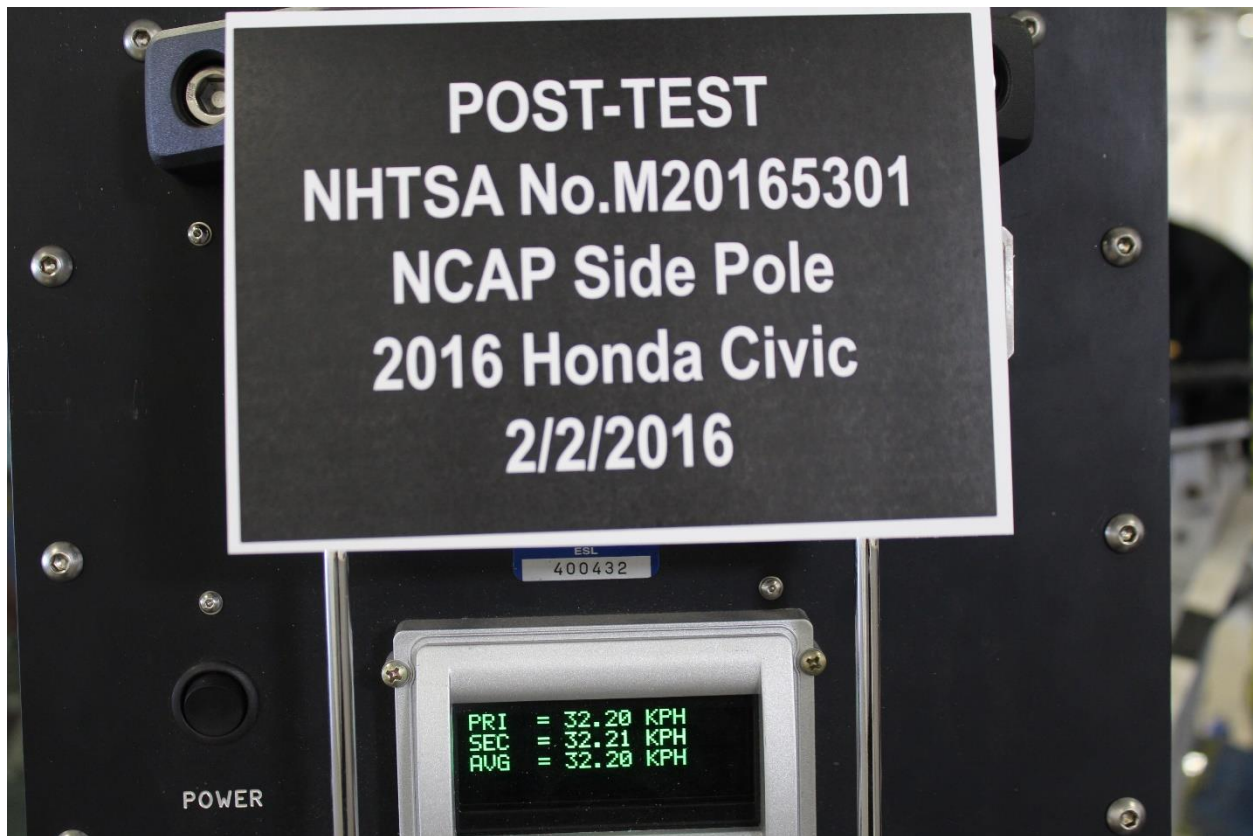
**Figure A-62: Post-Test Primary and Redundant Speed Trap Read-Out**
